Landslides and related features interpreted from aerial photographs:

LANDSLIDES AND RELATED FEATURES

OF THE BREEDING, KY. QUADRANGLE

U.S. Geological Survey
OPEN FILE MAP 82-653(H-5)

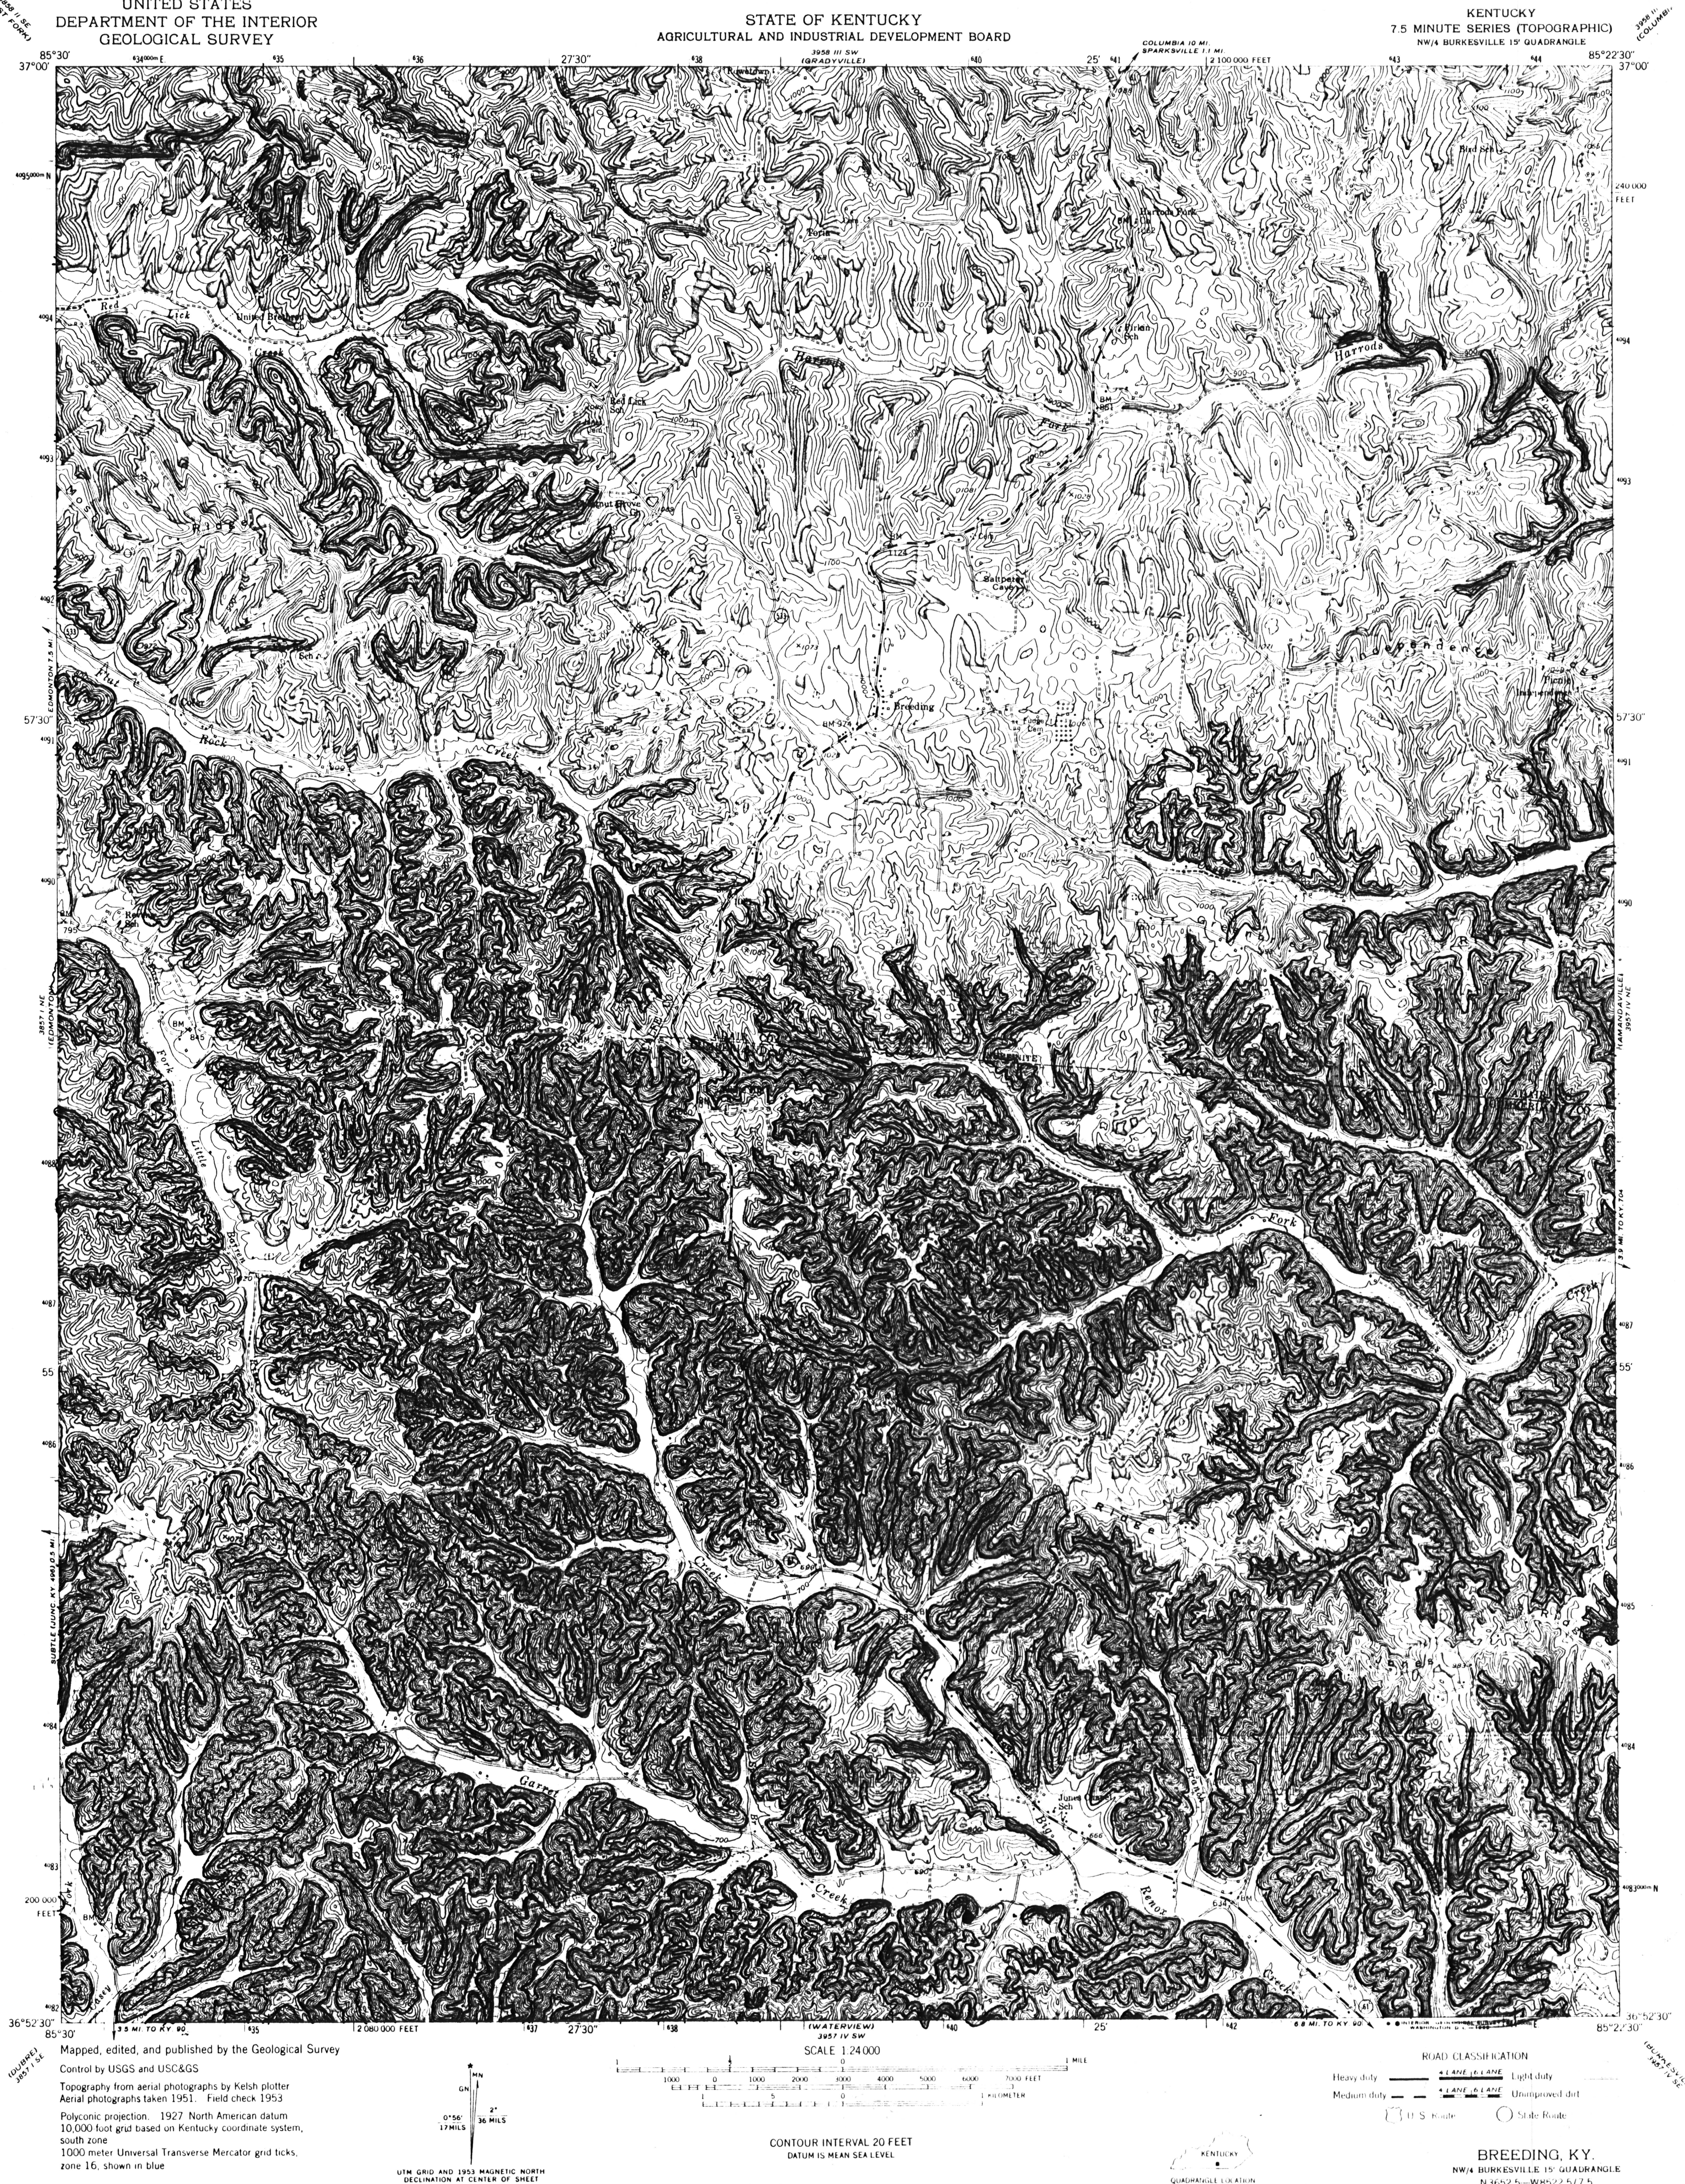
ACTIVE OR RECENTLY ACTIVE LANDSLIDE

Complex landslide composed of earthflow, debris slide, earth and rock slump. Identified from historical records, and from scars, debris and other field evidence. Ground extremely unstable; sliding accelerated by excavation, loading and changes in drainage conditions. May include areas with several active slides too small to be shown separately. Questioned where doubtful.

OLD LANDSLIDE

Area of extensive hummocky ground caused by earthflow and earth and rock slump. Lacks clear evidence of active sliding. Relatively stable in natural, undisturbed state, generally not affected by small structures properly sited in areas away from the edge of the toe; can be reactivated by extensive, rapid excavation, loading, and changes in ground water and surface water conditions. Area of old landslide probably includes recent ones not identified from field evidence or otherwise documented. Upslope boundary of landslide generally defined by modified scarp, but downslope (toe) may be gradational and not well defined. Questioned where doubtful.

COMBINATION LANDSLIDE

Area of recent and old slides in which individual slides are not identified.

COLLUVIAL SLOPE

Valley wall along major streams with slope as steep as 40° (85%); stony, clayey silt soil up to 50 ft. (15 m) thick; commonly buttressed by a terrace or bench at the toe of the slope; very susceptible to sliding by cutting of toe area, removal of terrace or bench, and overloading; slide commonly activated without apparent cause.

COLLUVIAL SLOPES WITH LANDSLIDES

Landslides too small or obscure to map individually.

AREAS SUSCEPTIBLE TO DEBRIS FLOWS AND DEBRIS AVALANCHES

Primarily shallow, narrow ravines and chutes with accumulation of stony colluvium generally 10 ft. (3 m) or less in thickness; susceptible to rapid movement during intense rainfall. Most ravines and chutes designated show evidence of former debris flows and avalanches.

AREAS SUSCEPTIBLE TO ROCKFALL

Steep, locally vertical, natural and man-made slopes and cliffs, 15 ft. (4.5 m) or more high; formed dominantly of sandstone, limestone, sandy shale, mudstone and claystone. Interbedded mudstone, claystone and shale weather rapidly leaving sandstone and limestone rock faces unsupported.

SOIL AND ROCK SUSCEPTIBLE TO LANDSLIDING

Soil and rock similar to that involved in landslides elsewhere in map area; primarily areas underlain by claystone, mudstone and shale associated with other rock types. Rock weathers rapidly on exposure forming clayey soil highly susceptible to sliding. Includes coves (U-shaped, shallow valleys) containing thick layers of clayey soil that are very susceptible to sliding where excavation breaks continuity of slope and where overloaded by artificial fill.

AREAS LEAST PRONE TO LANDSLIDES

Map areas in which no patterns or symbols are shown; primarily valley floors, ridge tops and broad benches; modification by excavation and fill may lead to local landslides.
